Infiltration Reduction Plan

Upper Nailbourne

July 2024
Version 5.0

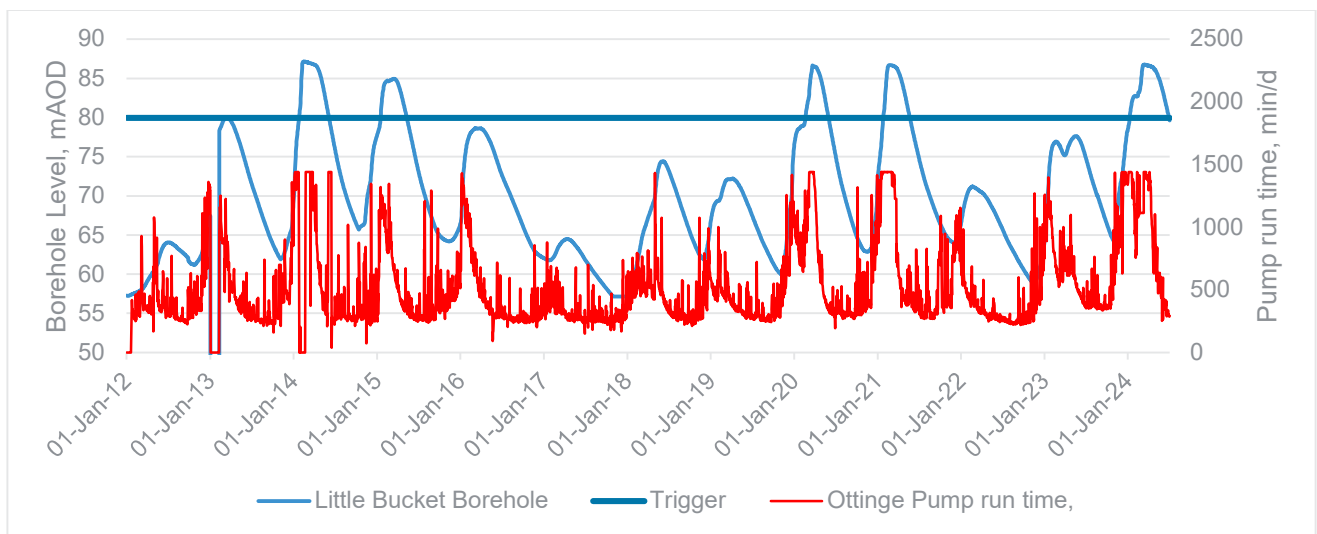
Figure 4.1 - Groundwater levels from 2012 to 2024

Figure 4.1 shows the groundwater levels recorded at Little Bucket since 2012. Groundwater treatment was required in 2012/13 and 2013/14, and tankering in 2014/15 with some repair activities in 2013/14 and 2014/15. Tankering was used for one day in February 2016, but only as a precautionary measure.

It can be seen for Figure 4.1 that the maximum groundwater level in 2022 was around 15m below that recorded in 2020 and 2021, tankering of flows was not required in the winter of 2022. It can also be seen that due to the wet winter of 2022/23 the groundwater recharge has commenced and levels in January have recovered to the normal range for the time of year despite the low starting point. Due to the wet summer and autumn of 2023 groundwater levels in the winter of 2023/2024 are similar to the levels recorded in the high groundwater seasons of 2014.

The graph on a previous page, in Figure 4.1, is an example of those used for predicting the earliest, average, and latest dates for when the trigger levels are forecast to be breached. This graph shows groundwater levels and an indication of flows. The only borehole currently available (with long term trends) in the area is at Little Bucket Borehole, Petham. It shows that groundwater levels have risen steeply during the winter of 2022 though the pump activity in the sewerage system appears shows slight variation and perhaps demonstrates some benefit of previous sewer sealing activity in the system.

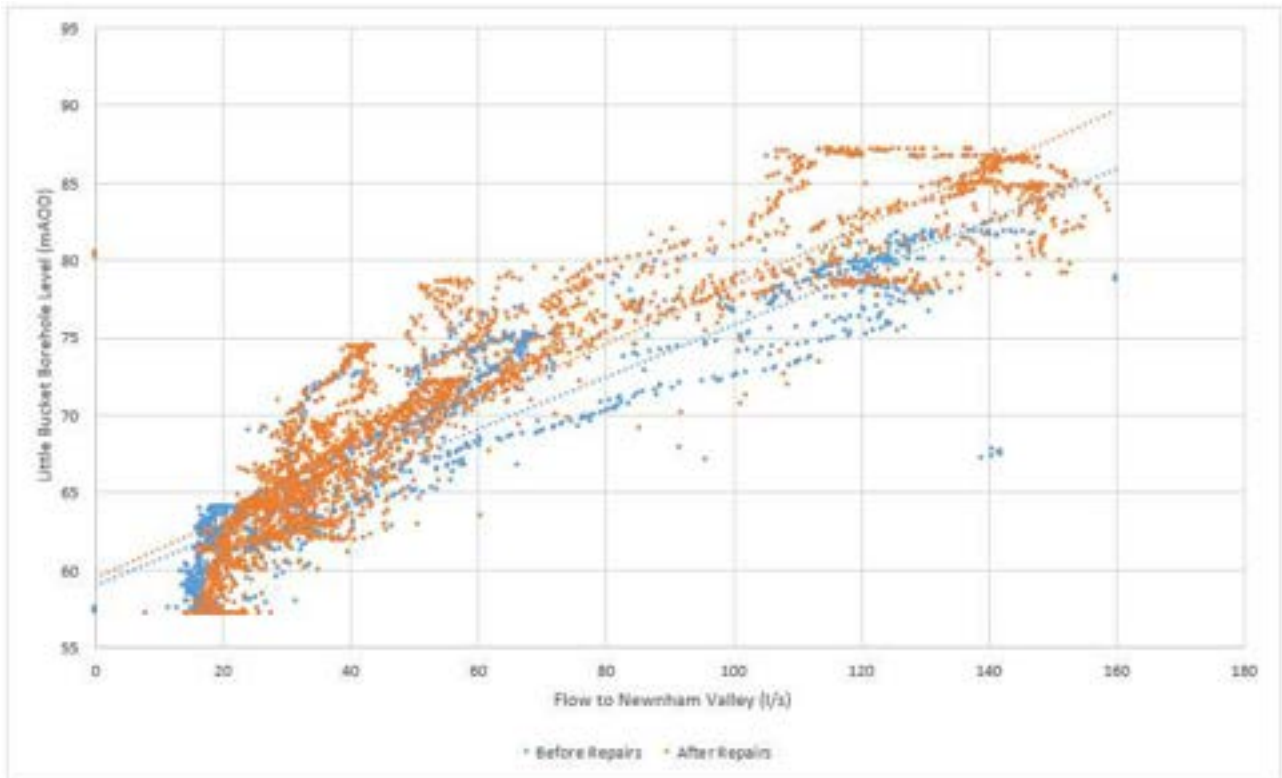
Figure 5.2 – Long Term Monitoring (Dec 2009 to Feb 2021)

Figure 5.2 shows the groundwater levels at Little Bucket Farm borehole plotted against flows to Newnham Valley WTW. Note that Newnham Valley WTW is in the Nailbourne catchment, downstream of the major repair works. However, it also processes sewage discharged from two adjacent sub-catchments. (Refer to the Background section for a description of the catchments feeding Newnham Valley WTW). Thus, the flows from the Nailbourne sub-catchment, form a part of the total flows to Newnham Valley WTW. The flow from Ottinge and Elham is a much smaller proportion of total flow to Hythe WTW and graph of the flow to treatment at Hythe is not currently available. Production of a similar graph for upper Nailbourne was considered however the fluctuation in total flow was not apparent.

Figure 5.2 quantitatively illustrates how flow varies with groundwater levels. It is reasonable that as groundwater levels increase, the rate of infiltration increases. Data points prior to the major repairs are plotted in blue: (Dec 2009 – Aug 2013). The data points for the period after major repairs (Jan 2014 – Jun 2021) are plotted in orange. Linear regression lines are also included for each set of data. These give an indication of the difference between average conditions for 'before' and 'after' repairs.

The difference in groundwater level between the lines is approximately 1.5 - 3m. In other words, for a given groundwater level, the corresponding flow is lower after the repairs. This confirms that the repair work has been effective.

For the period Dec 2009 to Jun 2021, the graph shows that groundwater levels rose higher after the repairs than they had before. This was due to natural variations in the weather. The maximum groundwater level before the repairs was 81.9 mAOD. After the repairs, groundwater levels at Little Bucket reached 87.2m. Despite these higher groundwater levels, flows to Newnham Valley WTW generally did not increase. Indeed, for the period of time after the repair works, the groundwater levels have been higher than 81.9 mAOD for approximately 18% of the time, yet flows have remained in a similar range to that which existed before.
